**RE: Progress report for October 2009 activities - Hecla Mining Company Apex Site
(EPA ID No. UT982589848, Docket No. RCRA-8-99-06)**

SUBJECT: Progress Report No. 66 for period ending October 31, 2009; Pond 2 Final Closure - Apex Site, Washington County, Utah

TO: Paul Glader (Hecla Mining Company)
FROM: Doug Gibbs (Monster Engineering Inc.)
DATE: 10/19/09
SUBJECT: **Surface Monument Survey Data Review – Apex Site**

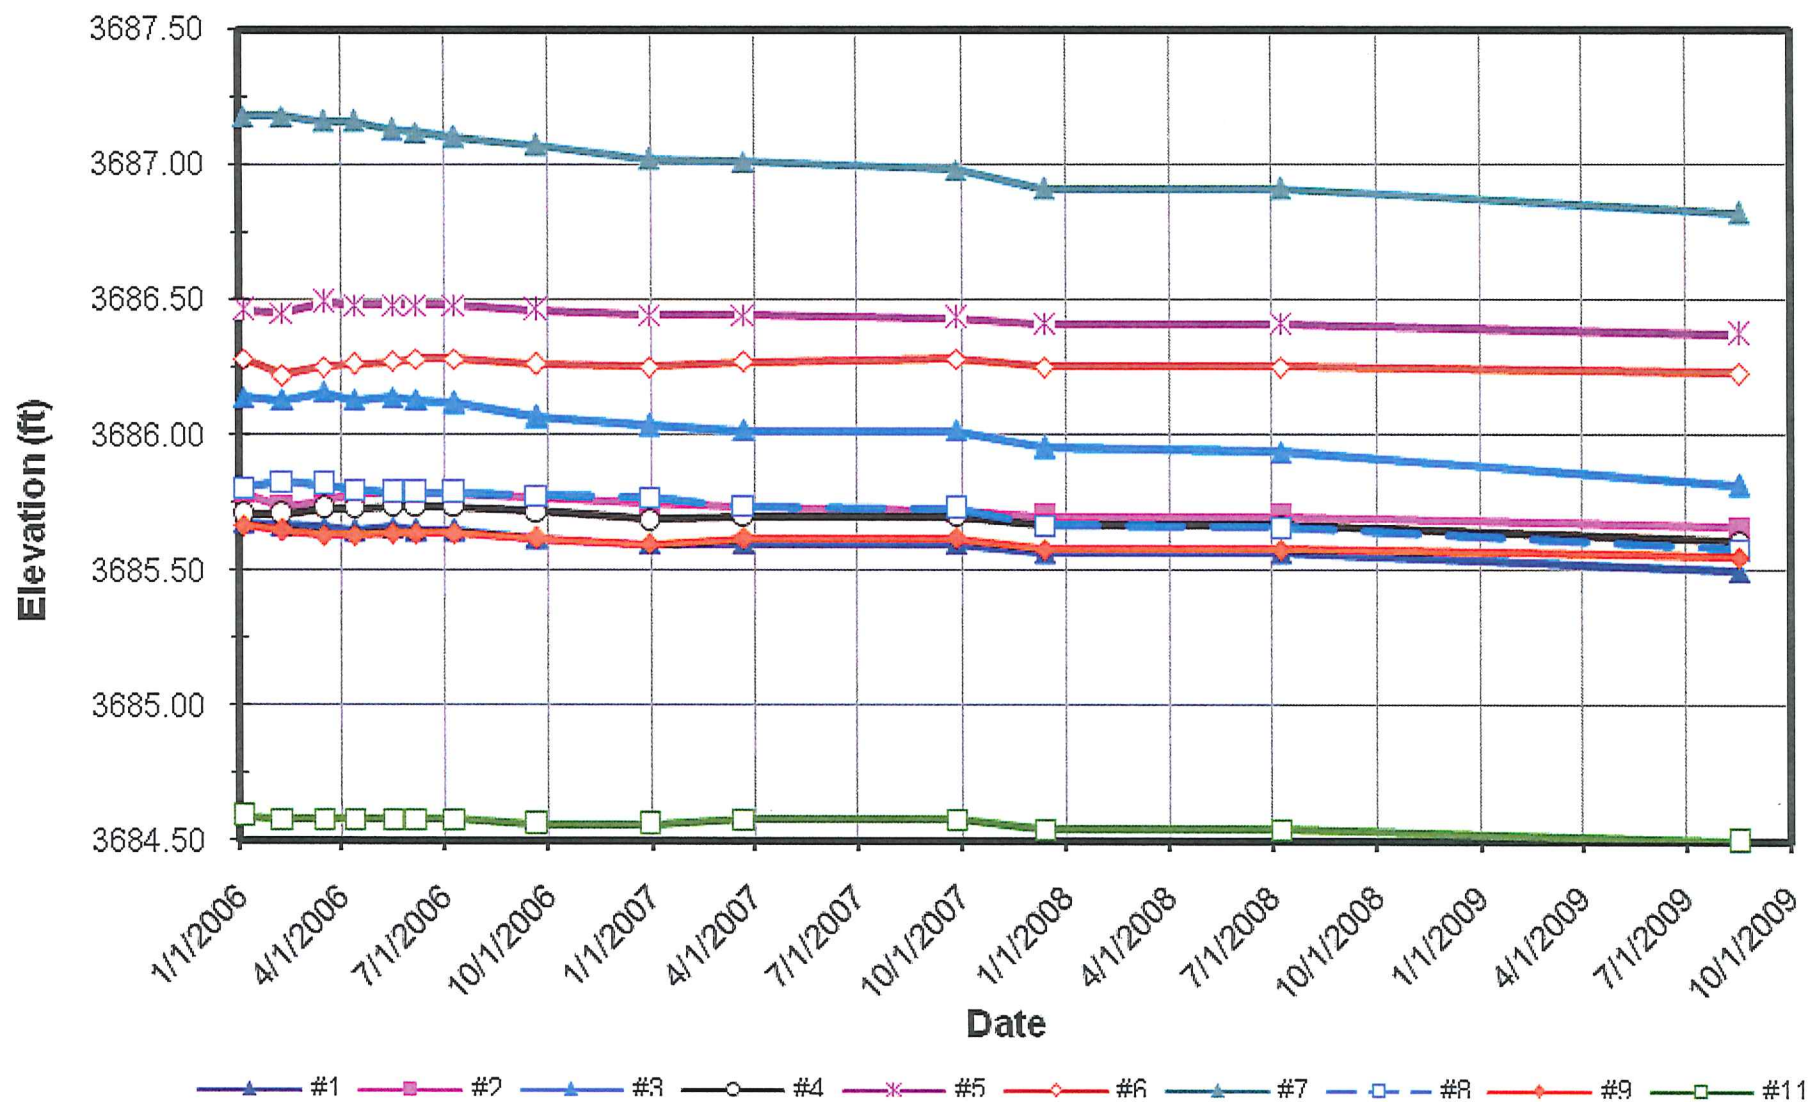
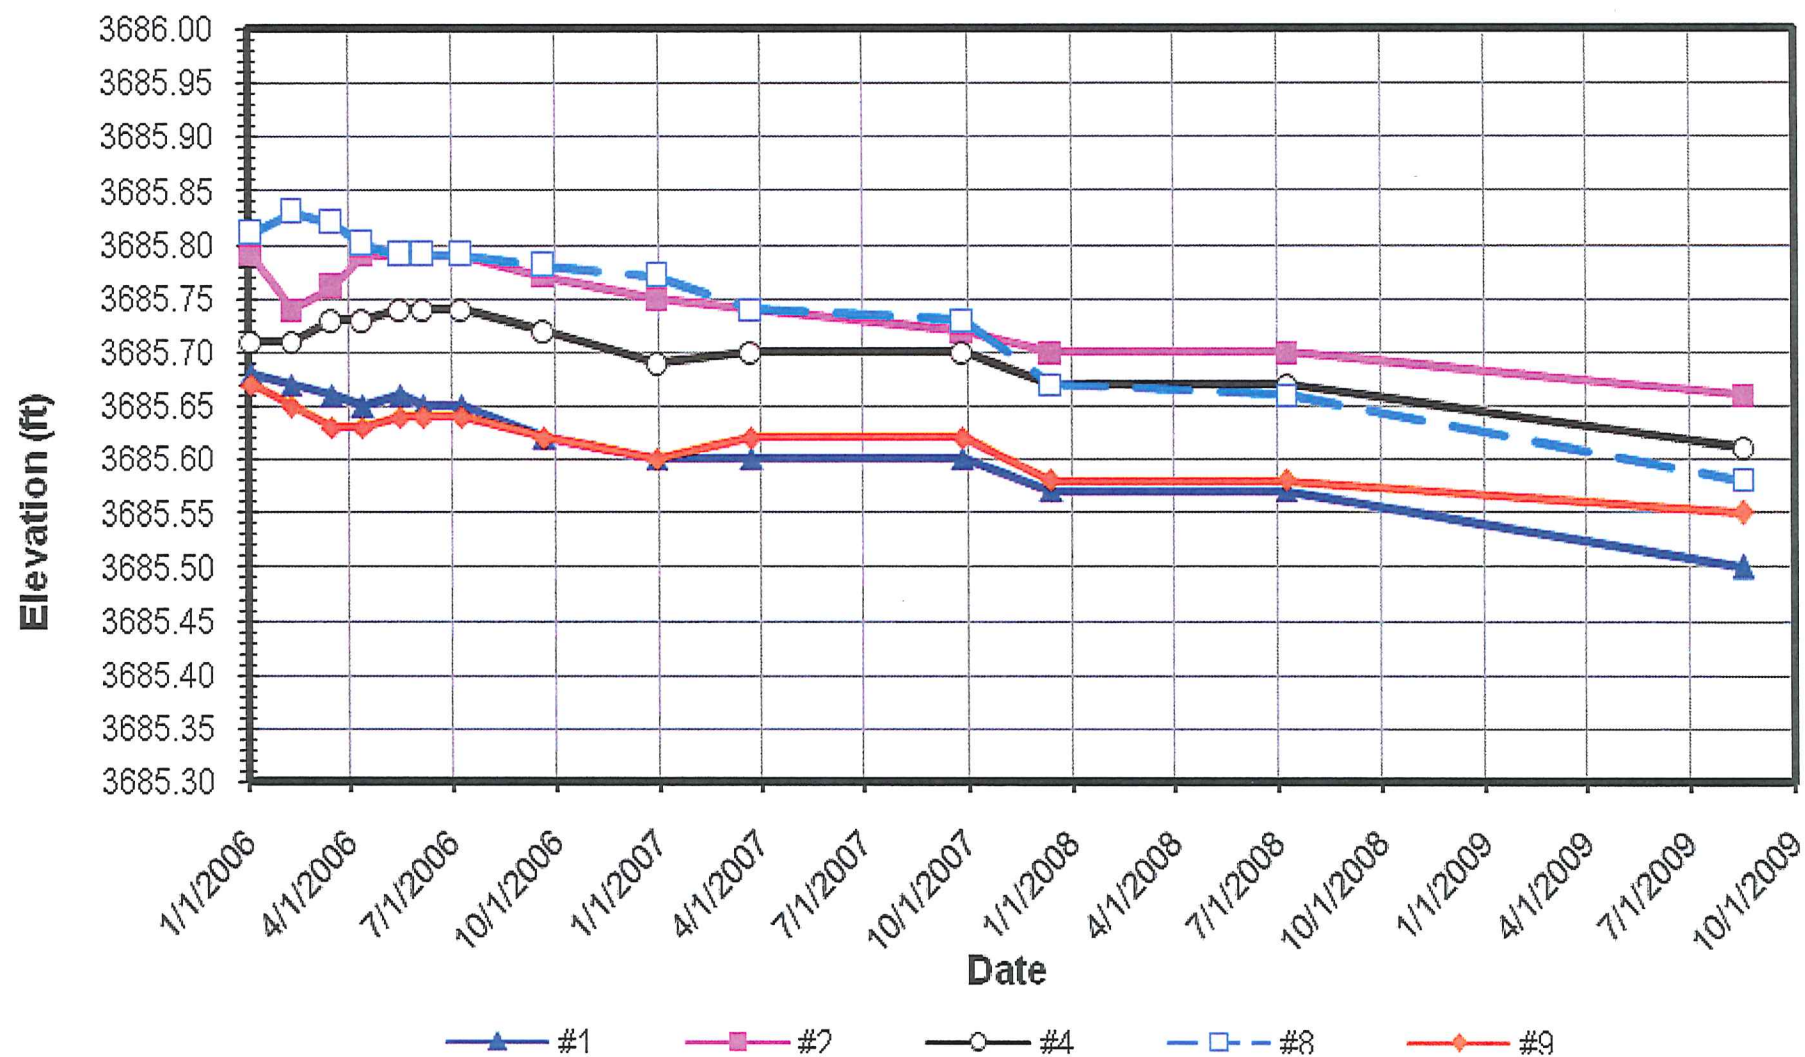
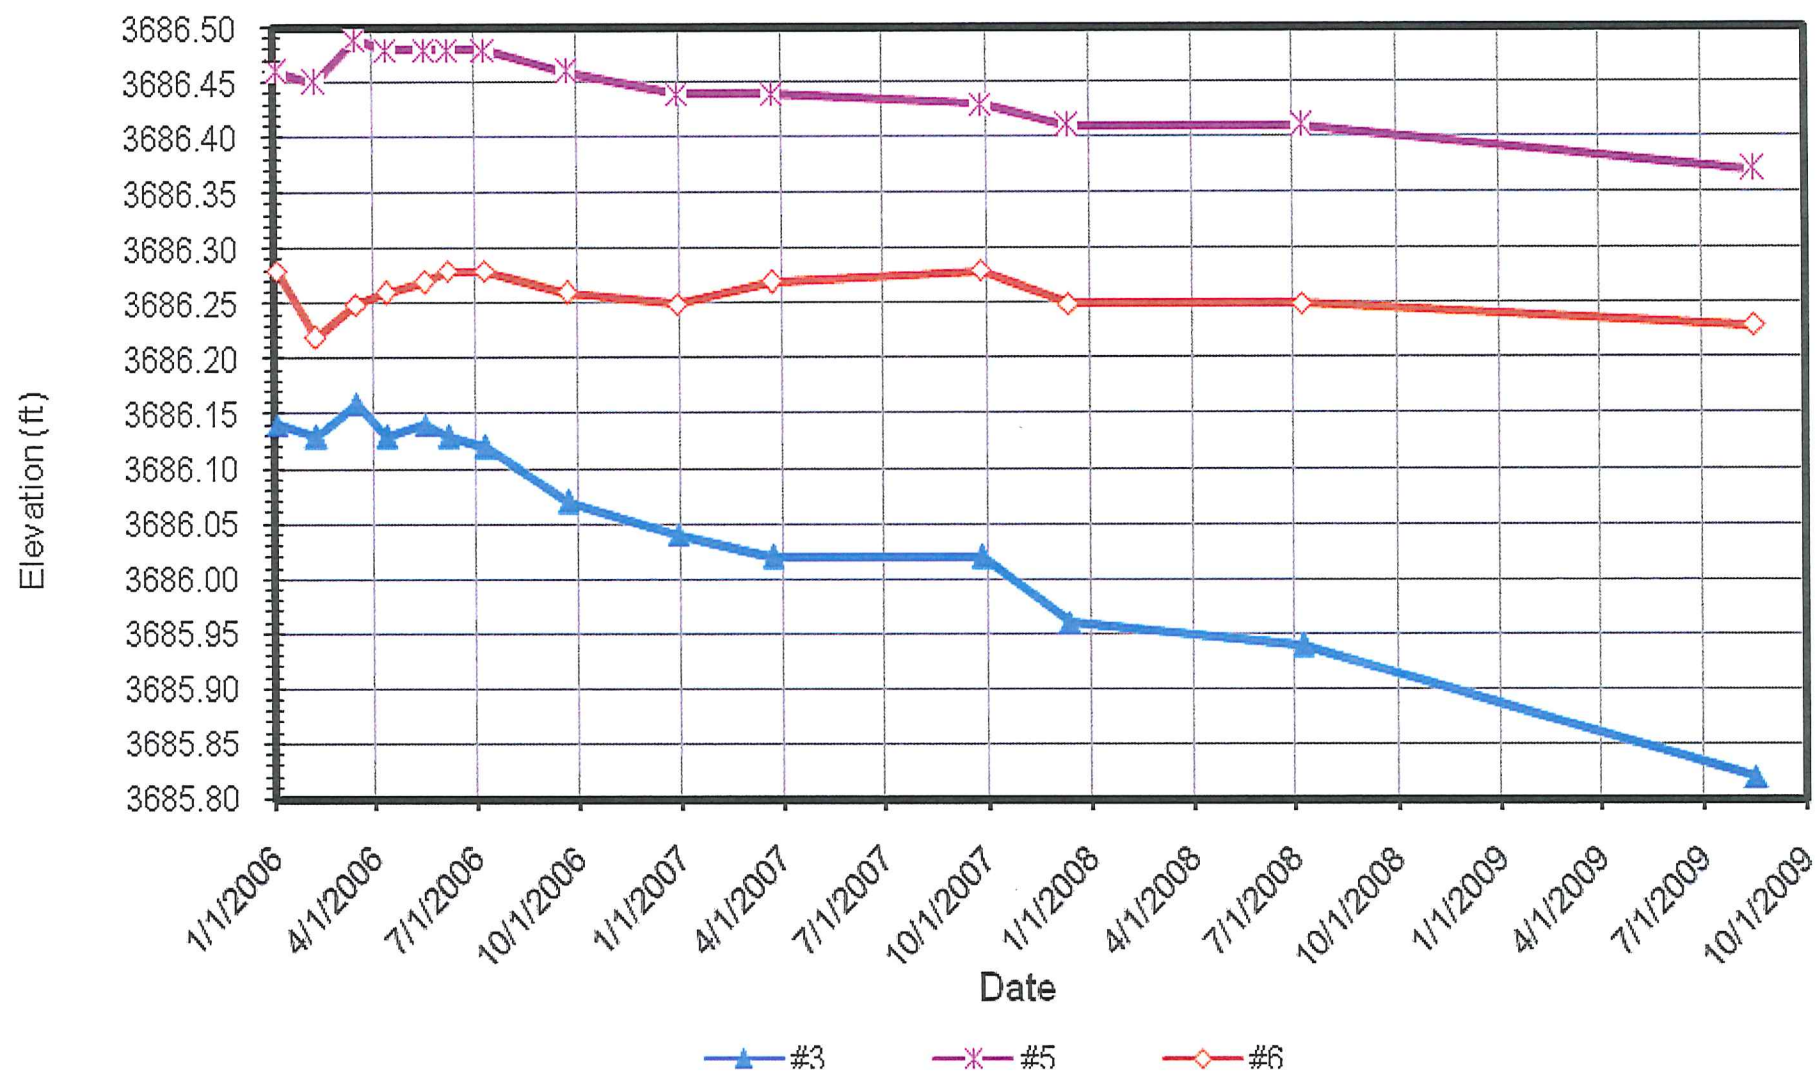
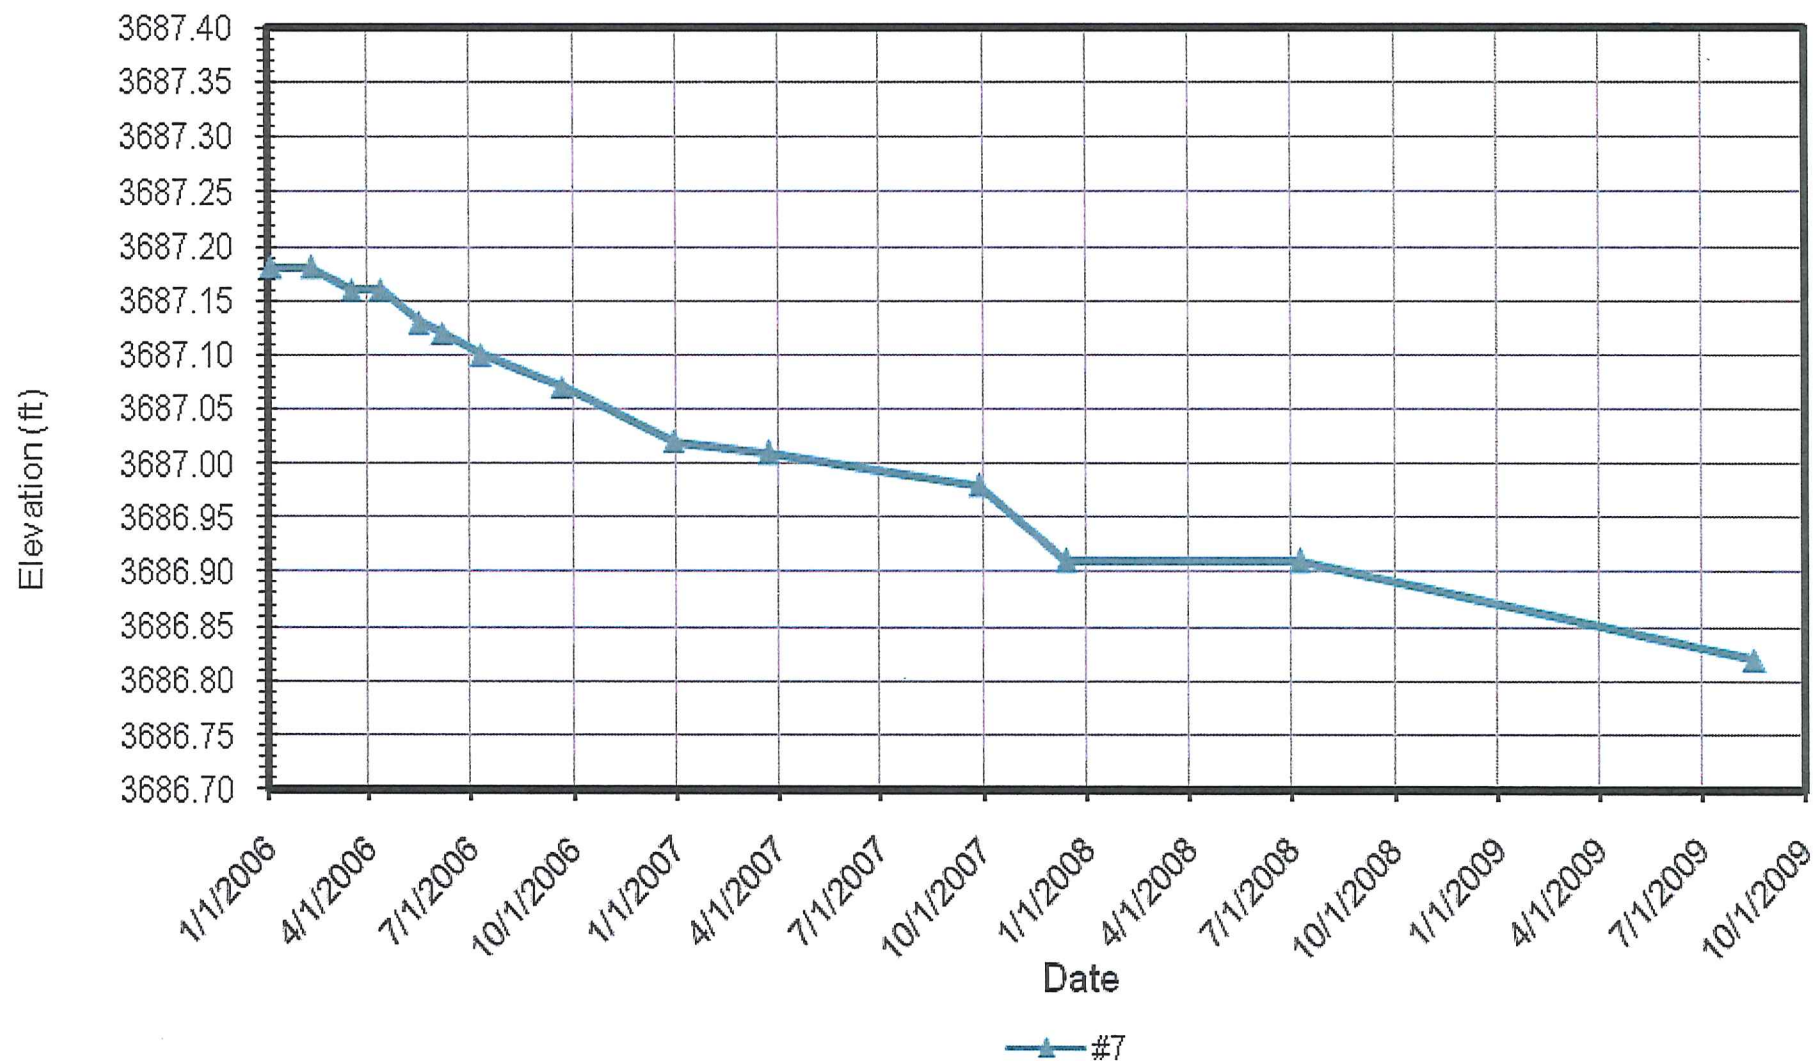
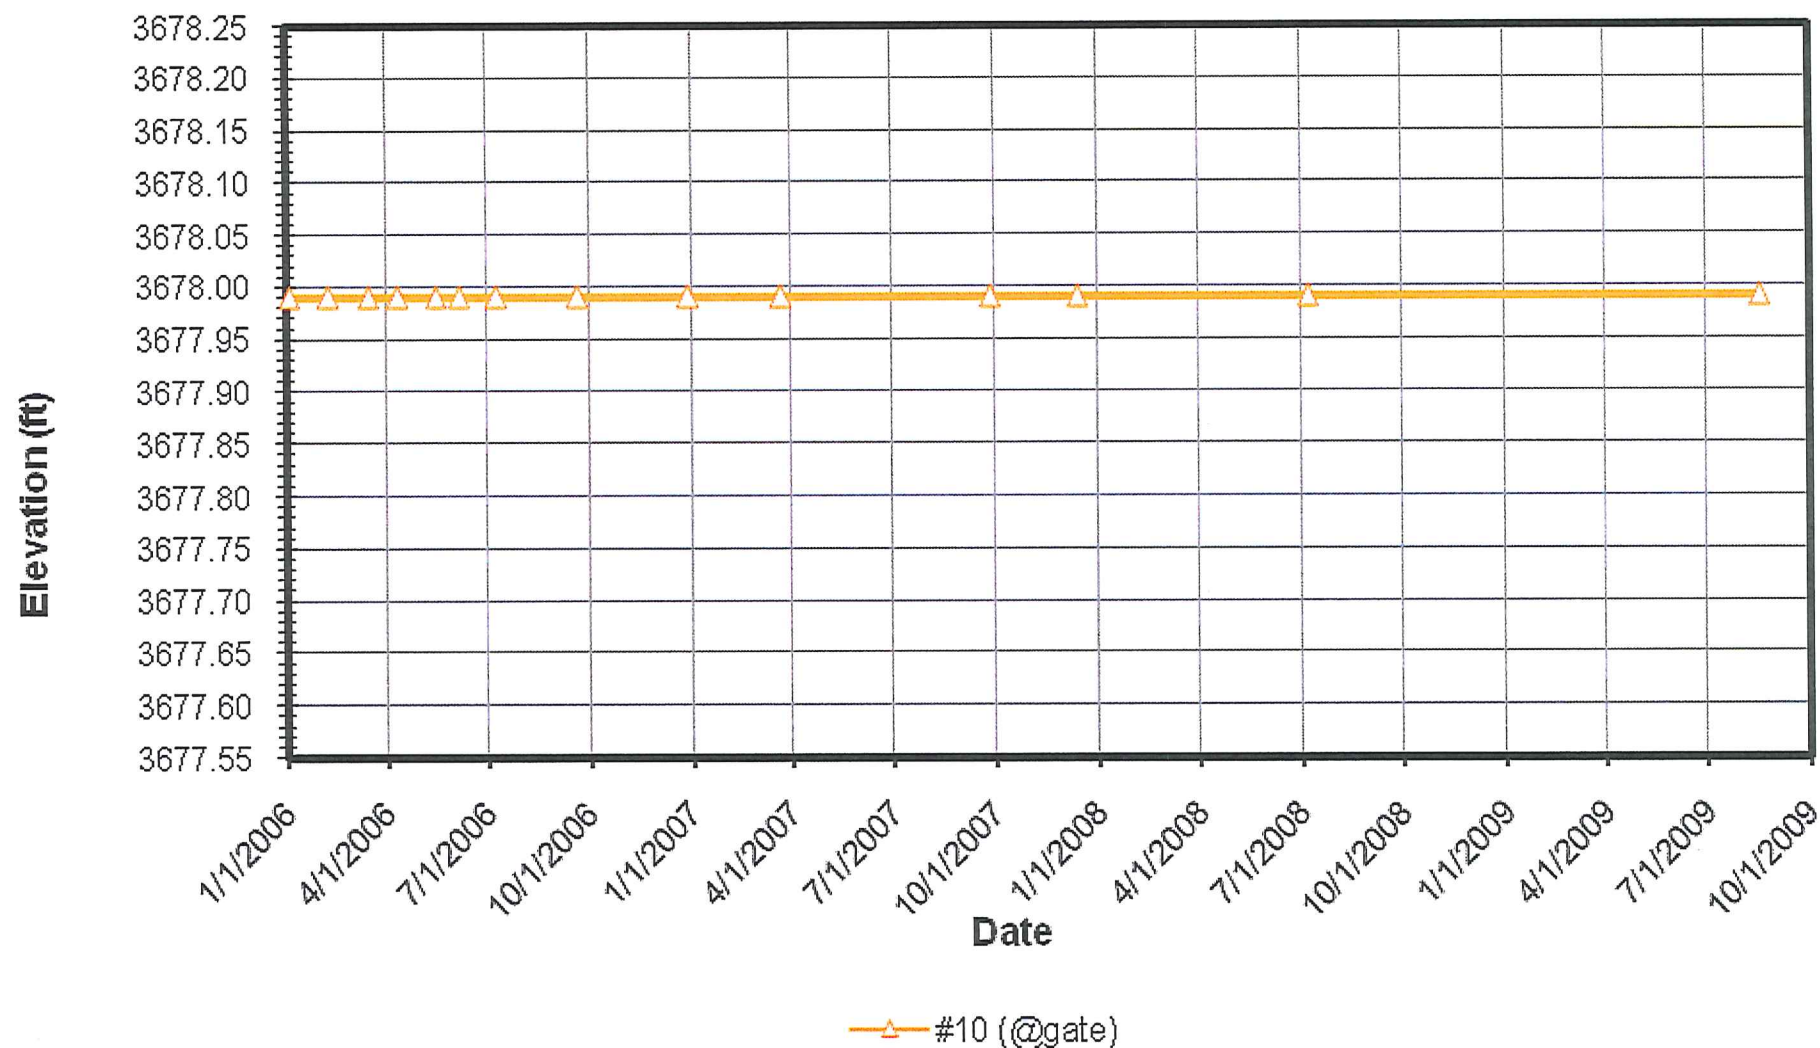
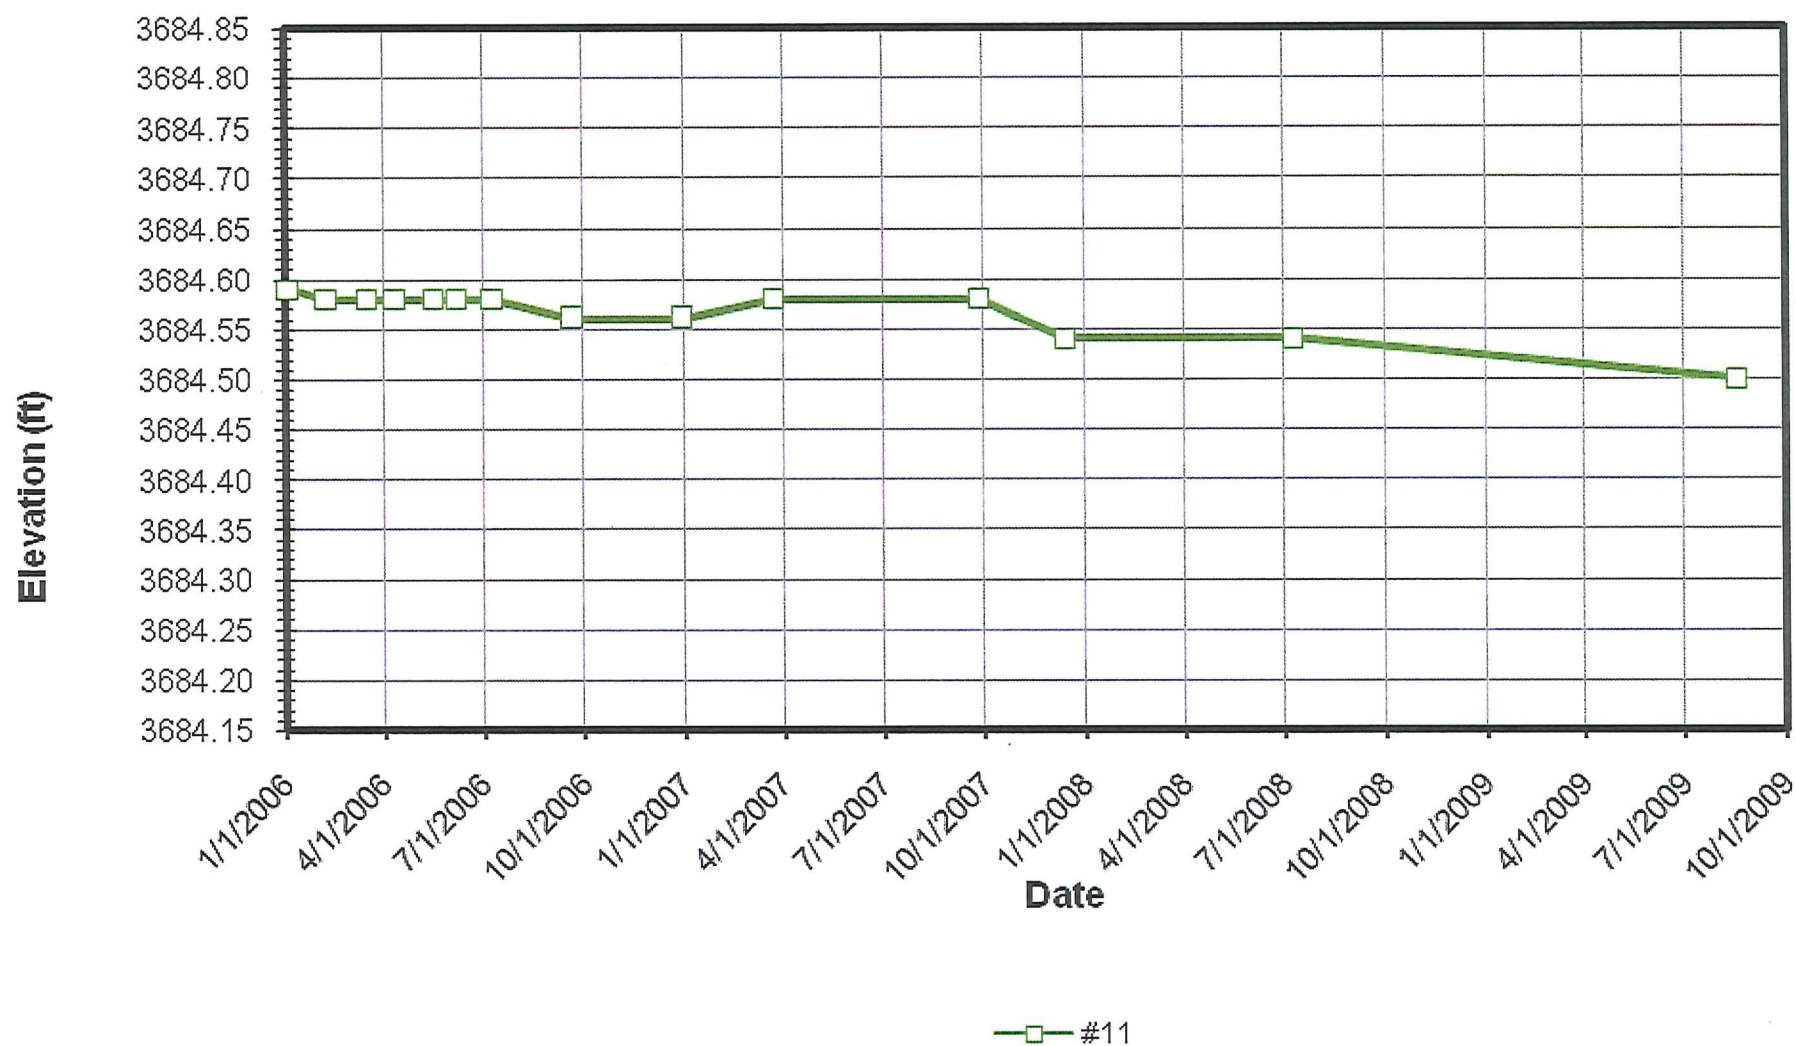
In summary the largest measured settlement is, as expected, near the center of the impoundment at -0.36 feet (monitor #7). Slightly greater settlement in and near the center of the impoundment is to be expected as significant quantities of fill were placed in this area during construction of the final cover system.

Survey data shows that the northern half of the impoundment has settled between 0.09 and 0.36 feet. The southern half of the impoundment has experienced very little settlement (0.05 to 0.12 feet). Greater settlement is expected in the northern half versus the southern half due to methods utilized to place the original cover system prior to final reclamation activities. According to Chris Gypton and Alan Wilson, placement of the original cover system started in the southwest corner. Additional cover materials were then dumped in that corner and pushed across the impoundment towards the northeast corner. The result of this placement method was that prior to final cover construction, the overall thickness of waste in the southern end of the impoundment was less than that in the northern end.

There continues to be no concerns to date with settlement. There are no low spots and no signs of ponding rain water. As expected with long-term consolidation, the data shows that settlement rates are slightly decreasing over time. Consolidation of waste materials and final reclamation cover materials appears to be very minimal and decreasing. Additionally, it is highly unlikely that any liquids are leaving the impoundment.

Based on data collected to date, MEI recommends that Hecla continue with their current plan and collect elevation data annually. Please contact me if you have any questions concerning this review.
